COMBUSTION TURBINE (CT) HOT SECTION COATING LIFE MANAGEMENT

Semi Annual Technical Progress Report

Agreement Number: DE-FC26-01NT41231

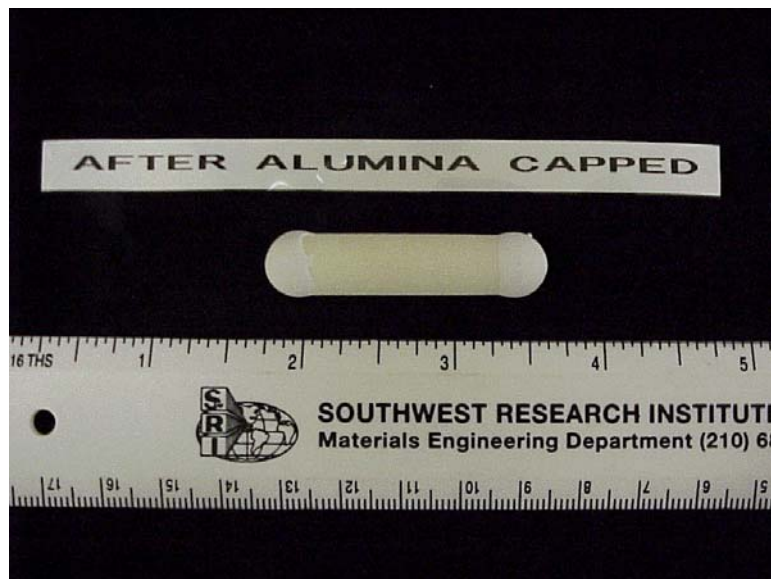
Dimensions of a hollow burner rig test specimen. The TBC coating was applied on the surface between the arrowheads.

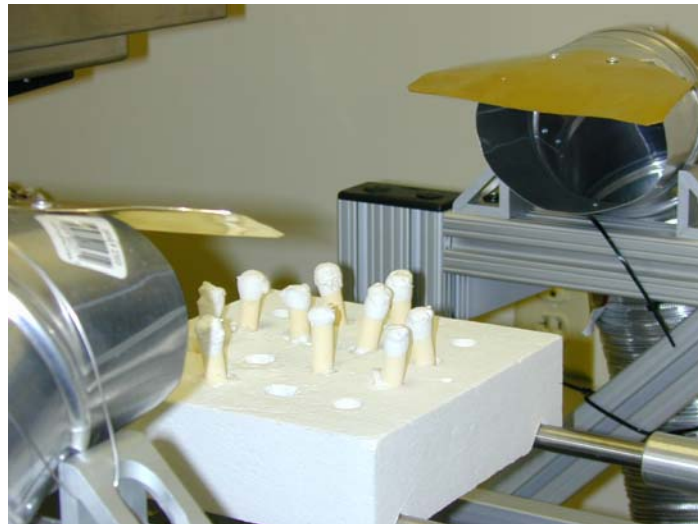
Figure 5-3
Photographs of (a) thermal cycling furnace with a computer-controlled moving arm and cooling system, (b) specimens immediately after their removal from the furnace, and (c) forced-air-cooled specimens

Thermal cycling exposure tests were conducted using a vertical CM furnace, shown in Figure 5-3. Southwest Research Institute designed and fabricated a computer-controlled moving arm that transfers specimens in and out of the furnace and to the cooling system. For thermal cycling exposure testing, coated specimens were inserted into the furnace, which was maintained at a desired peak temperature and held at that temperature for 55 minutes prior to moving them into the cooling system. The specimens were forced-air cooled for 10 minutes, to room temperature, and then they were reinserted into the furnace. The tests were performed at two peak temperatures; 1850°F (1010°C) and 1950°F (1066°C). These results were used to generate the constants for the TBC life model development. For the model validation, a 24-hour hold test was also performed at the peak temperature of 1950°F (1066°C).

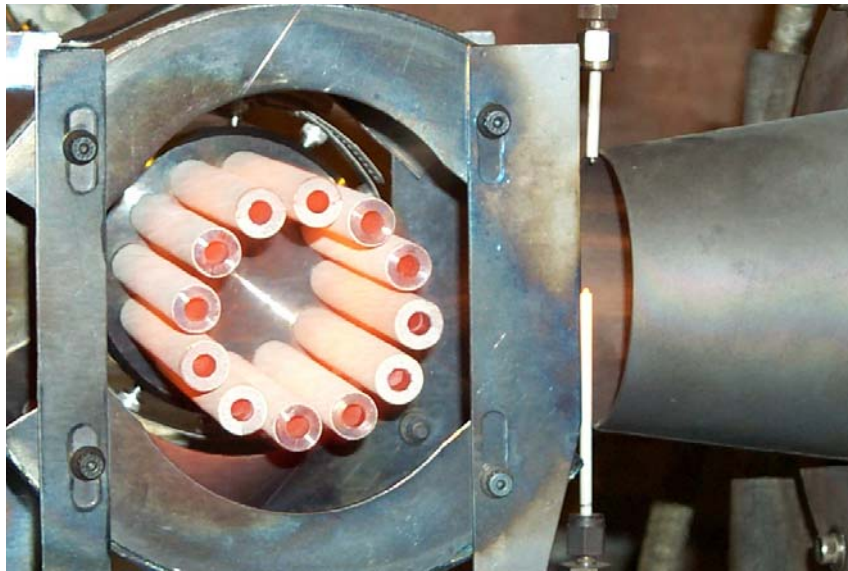
Figure 5-4
Photograph of the NRC high-velocity burner rig system.

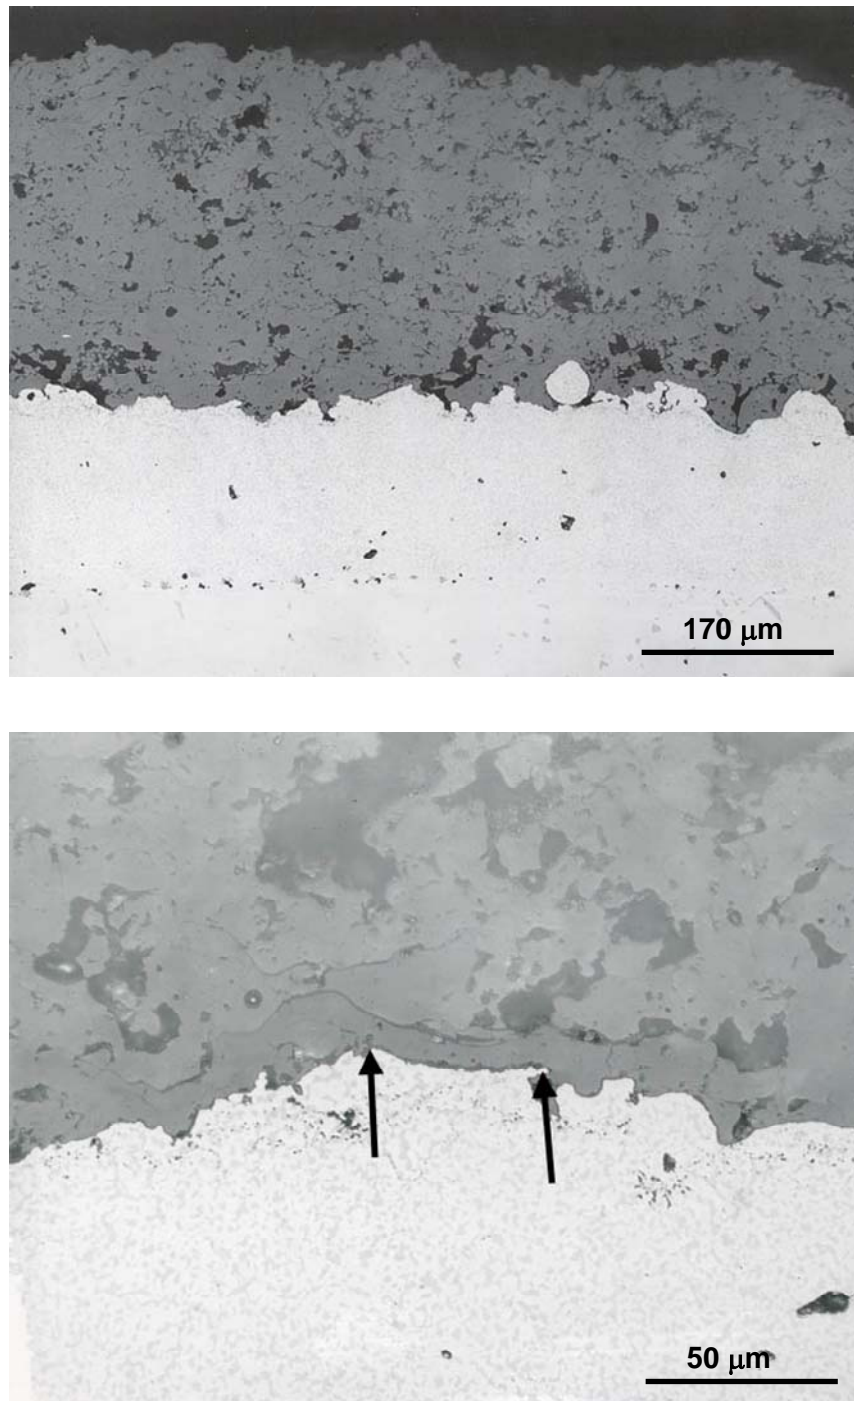
Figure 5-5
Optical micrographs of as-coated TBC on an NiCoCrAlY-coated GTD-111 specimen. The arrows point to delamination cracks at the TBC/bond coat interface.

Typical microstructures of the bond and ceramic coatings in the as-deposited and heat treated condition are presented in Figures 5-5 through 5-8. Among the four specimens, thickness of the bond coating varied from approximately 130 μm (0.005 inch) to 155 μm (0.006 inch). The composition of the bond coating was found to be comparable to the results presented in Table 1-3. A thin layer of platinum, approximately 4 μm in thickness is evident in Figures 2-7 and 2-8 between the bond and top ceramic (TBC) coatings. The bond coating on all specimens was dense and exhibited a microstructure consisting of fine β phase (NiAl) in a matrix of γ (Ni-Cr-Co solid solution). The outer surface of the bond coating on all specimens exhibited irregular surface topography, which is normal for the LPPS-processed coatings. The rough surface is required for adhesion of air plasma TBC [9]. The thickness of the TBC on the specimens varied from about 250 to 375 μm (0.010 to 0.015 inch). Examination of the bond coating/TBC interface revealed a thin and discontinuous thermally-grown oxide (TGO) scale in isolated areas and a few micro-delamination cracks at the interface. These cracks were parallel to the interface and were about 50 μm (0.002 inch) long. Propagation of these cracks during isothermal or thermal cycling exposure can lead to TBC spallation. The microstructure of the TBC exhibited a layered structure resulting from the splatting of the powder particles during the deposition process. Pores/voids and microcracks were seen in the coating, which is normal for an APS-processed TBC [9-12].

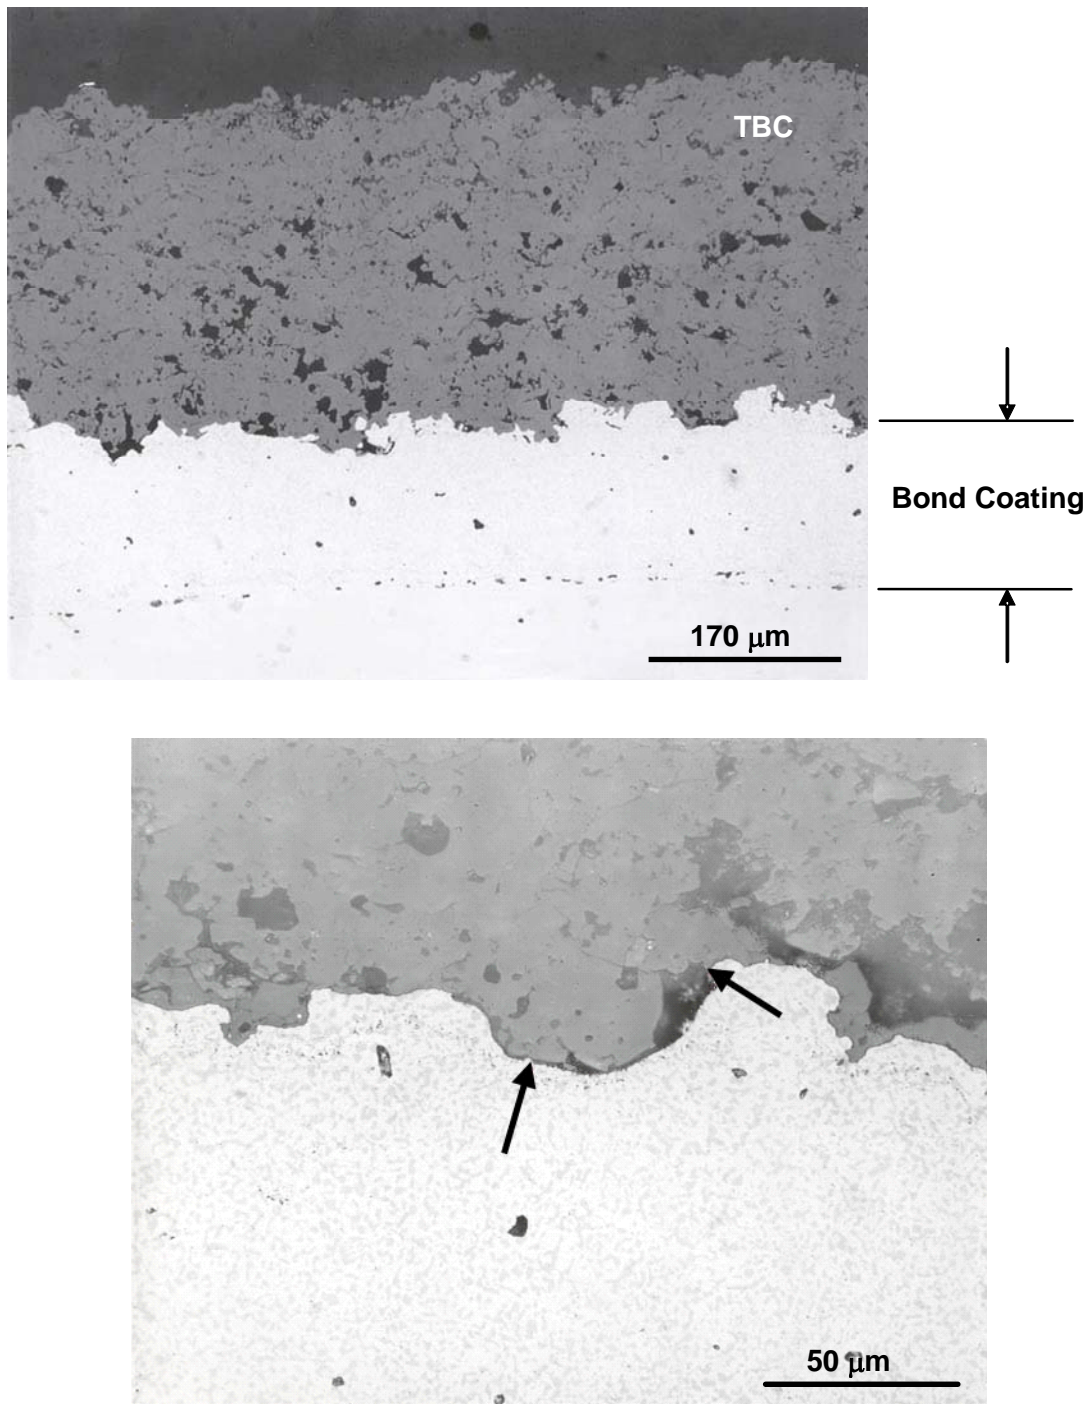
Figure 5-6
Optical micrographs of as-coated TBC on an NiCoCrAlY-coated IN-738 specimen. Arrows point to delamination cracks at the TBC/bond coat interface.

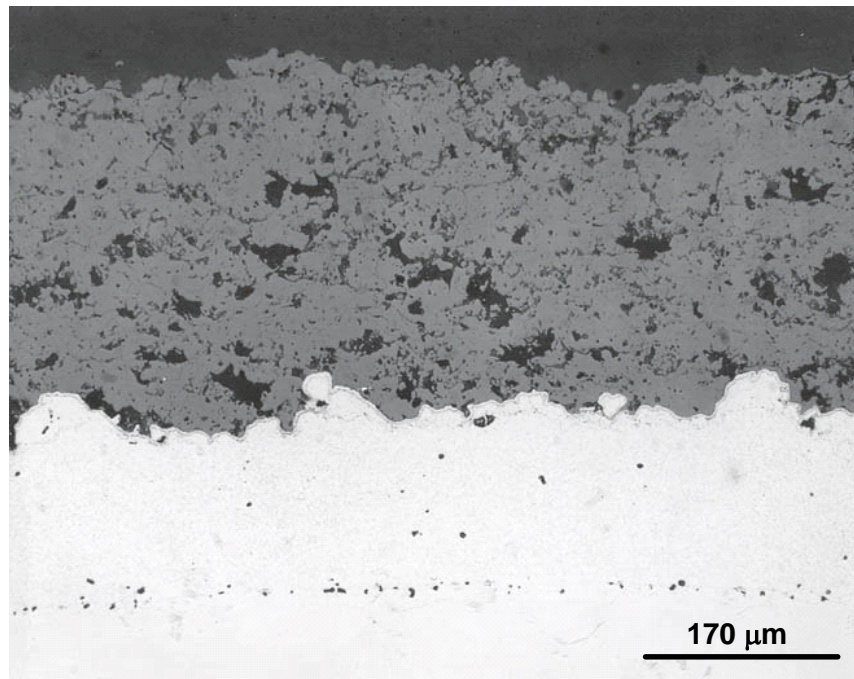
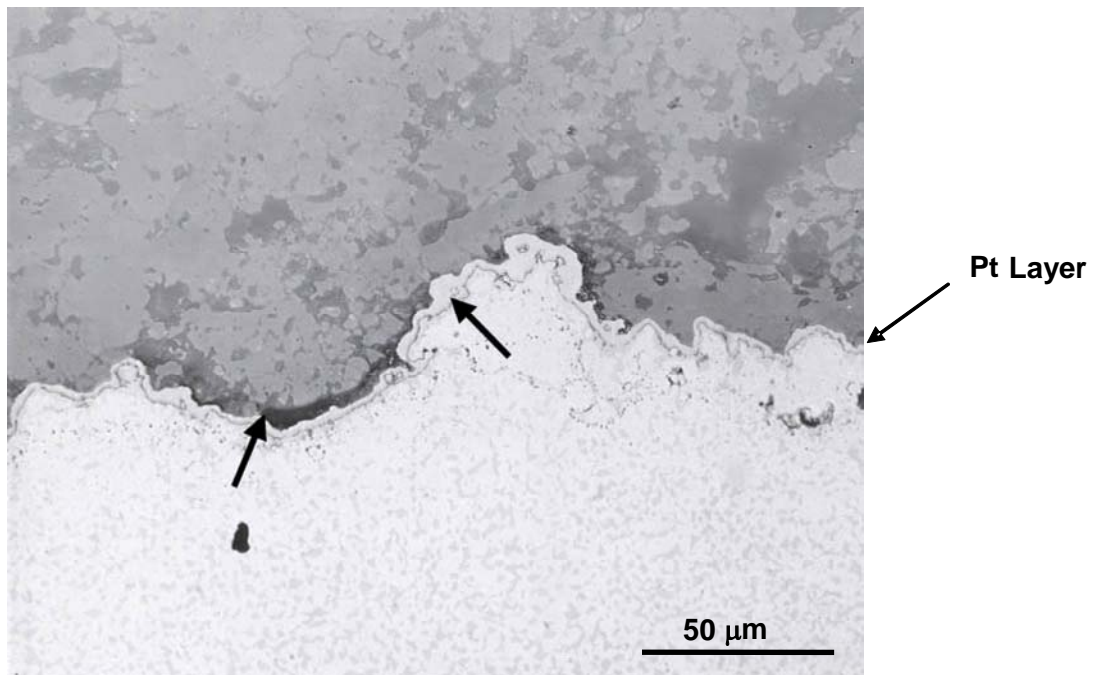
Figure 5-7
Optical micrographs of as-coated TBC on a platinum-plated NiCoCrAlY coating on a GTD-111 specimen. Arrows point to delamination cracks.

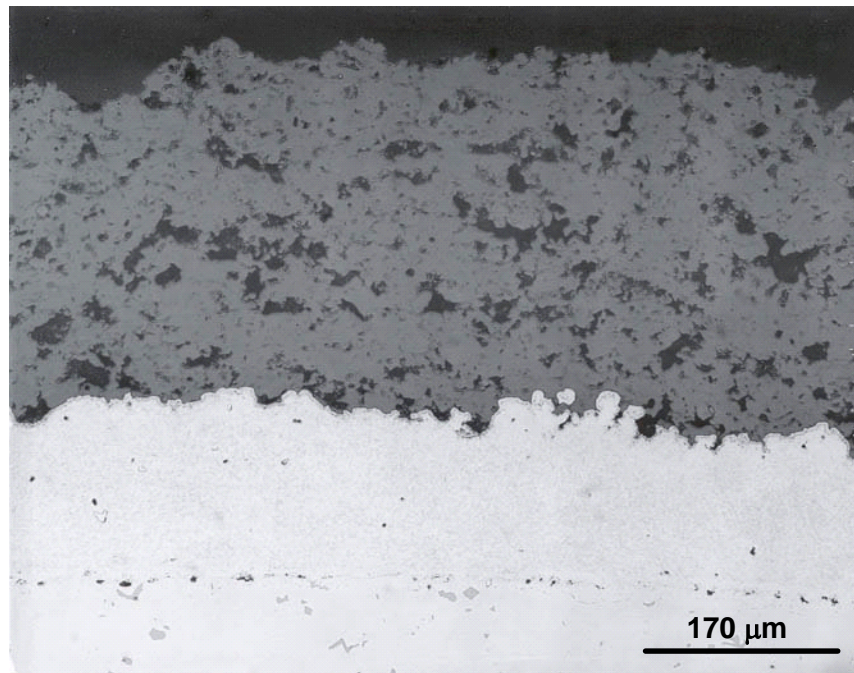
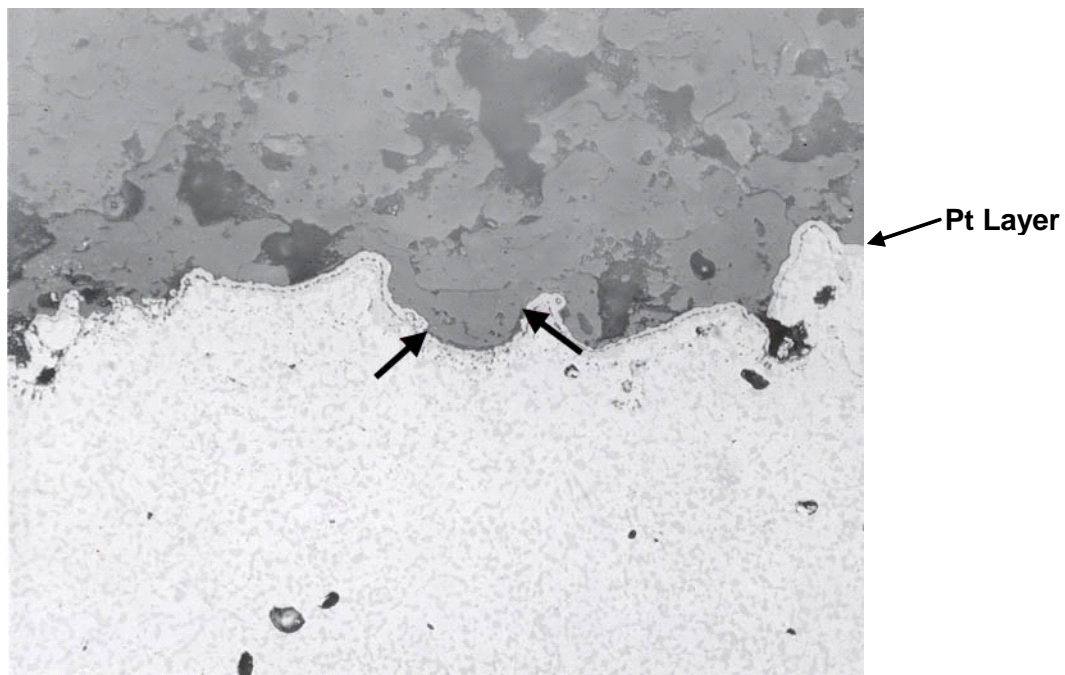
Figure 5-8
Optical micrographs of as-coated TBC on a platinum-plated NiCoCrAlY coating on an IN-738 specimen. Arrows point to delamination cracks at the TBC/bond coat interface.

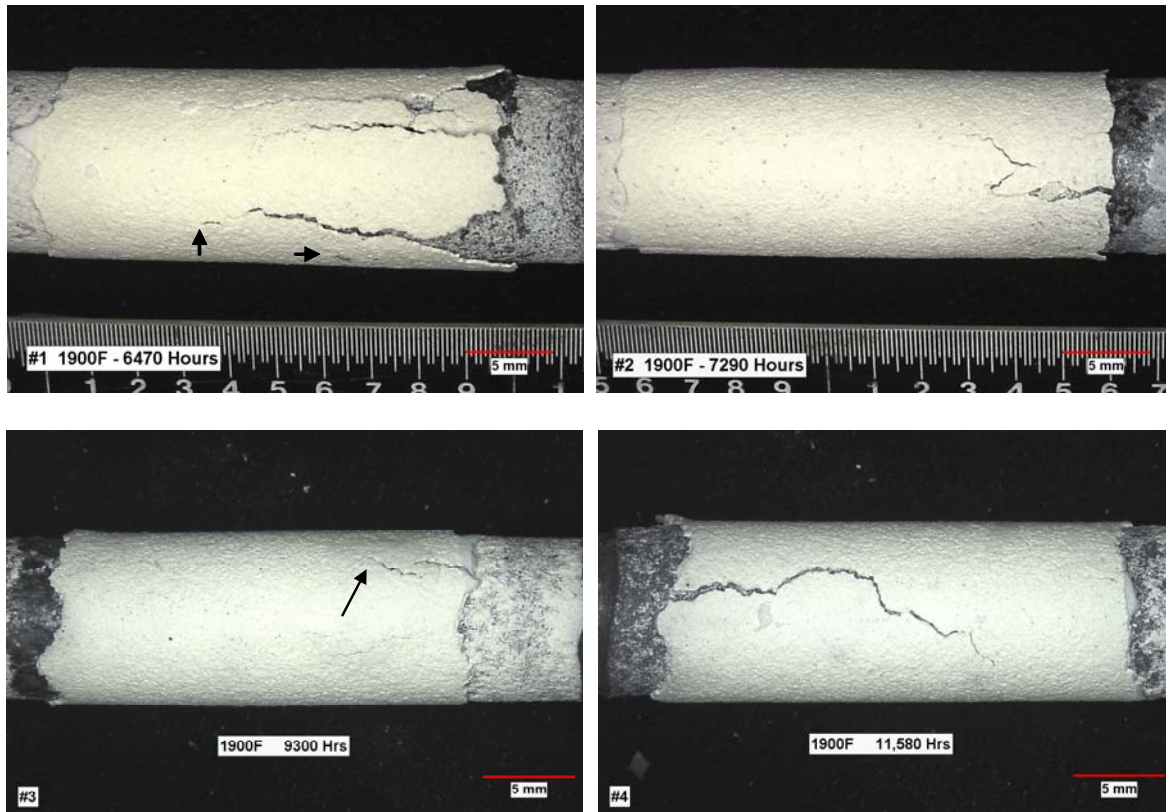
Figure 5-10
Condition of the coated specimens after exposure at 1900°F (1038°C). Arrows point to cracks that were not initiated from the end faces of the specimen.

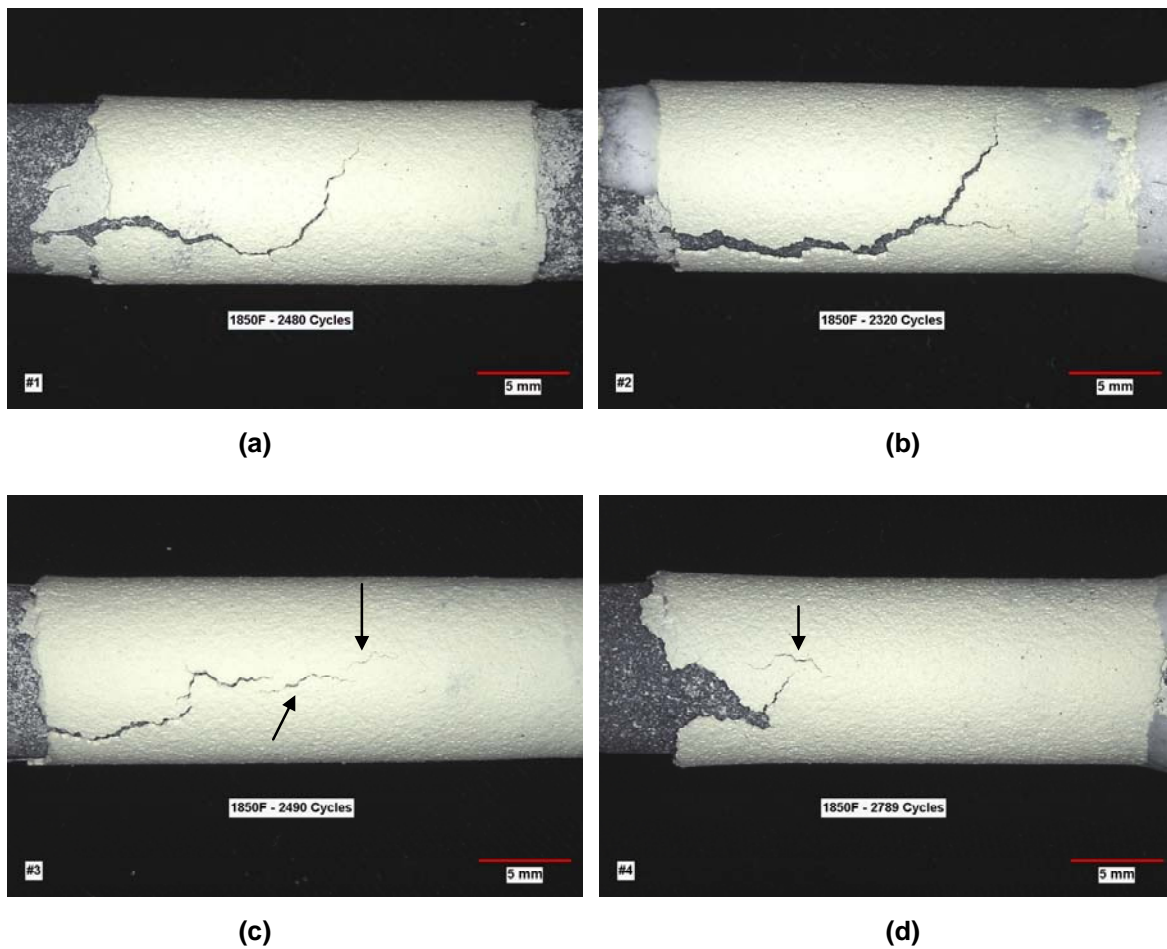
Figure 5-12
Photographs of TBC (a) on MCrAlY-coated GTD-111 specimen after about 2480 thermal cycles, (b) on MCrAlY-coated IN-738 specimen after about 2320 thermal cycles, (c) on Pt-plated MCrAlY-coated GTD-111 specimen after about 2490 thermal cycles, and (d) on Pt-plated MCrAlY-coated GTD-111 specimen after about 2789 thermal cycles between the peak temperature of 1950°F (1060°C) and room temperature. Arrows point to cracks that did not initiate from the end faces.

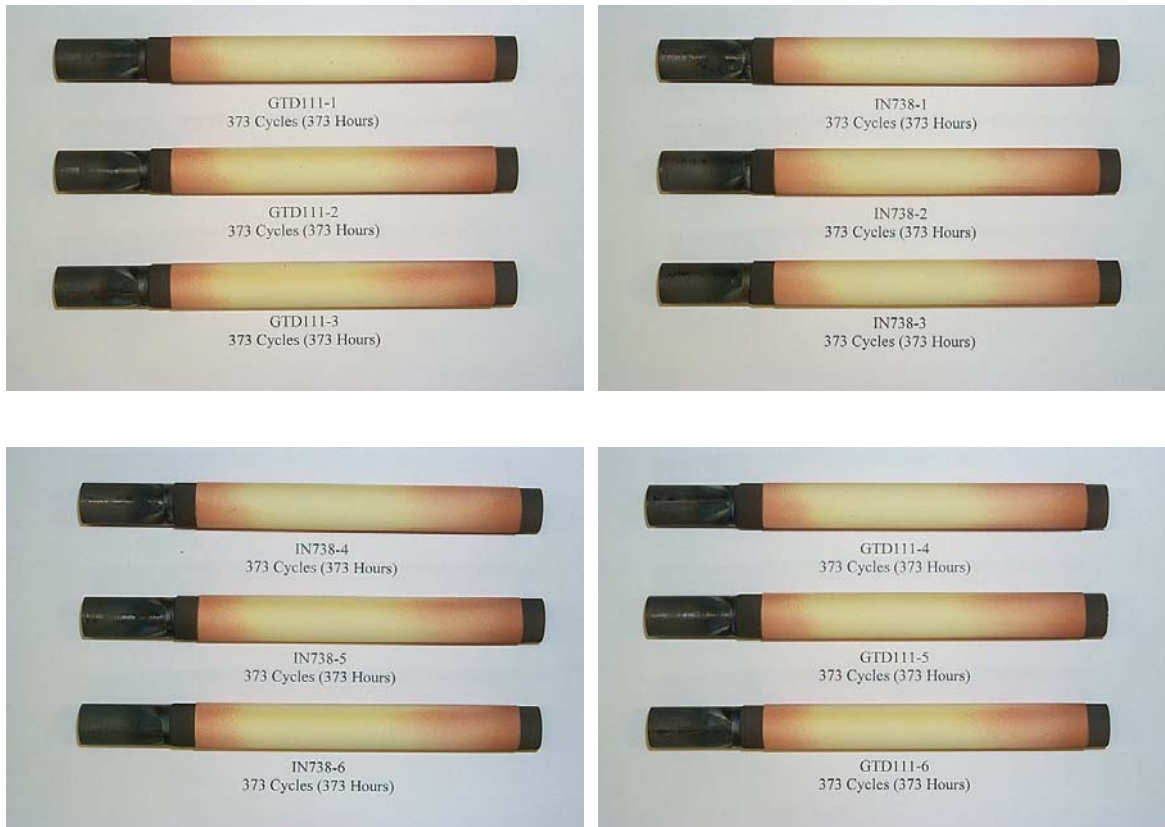
Figure 5-13
Condition of the burner-rig test specimens after 373 one-hour thermal cycles between the peak temperature of 1950°F (1066°C) and room temperature.

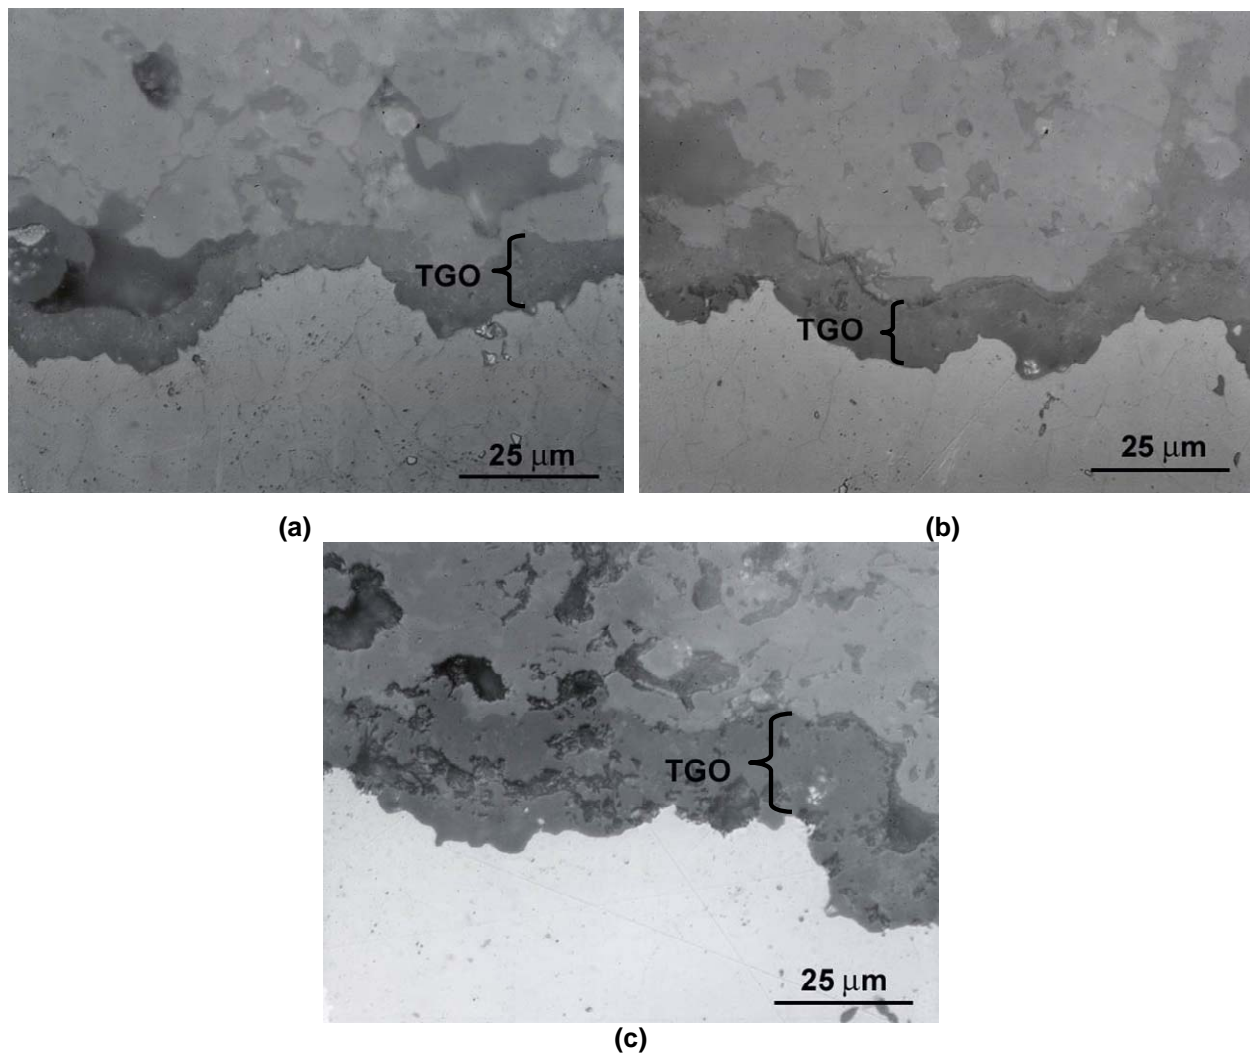
Figure 5-22
Optical micrographs showing variation of TGO thickness on the NiCoCrAlY-coated GTD-111 specimen after (a) 2015 hours of exposure, (b) 5015 hours of exposure, and (c) 9850 hours of exposure at 1850°F (1010°C).

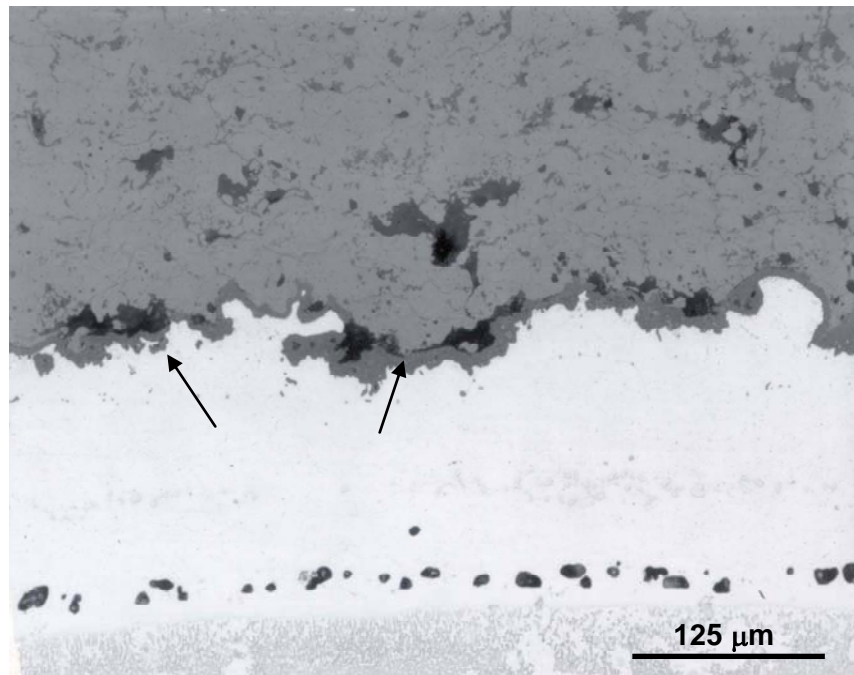
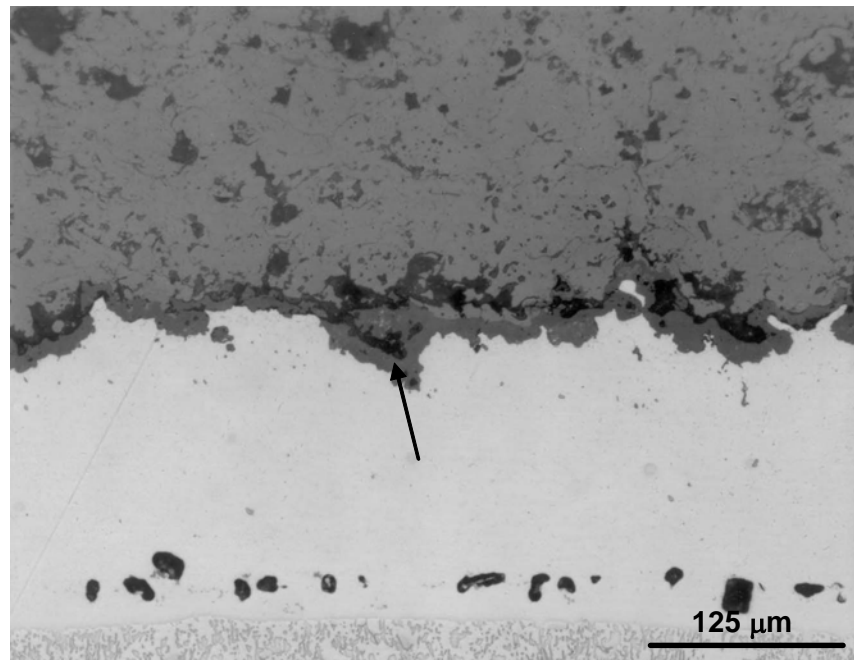
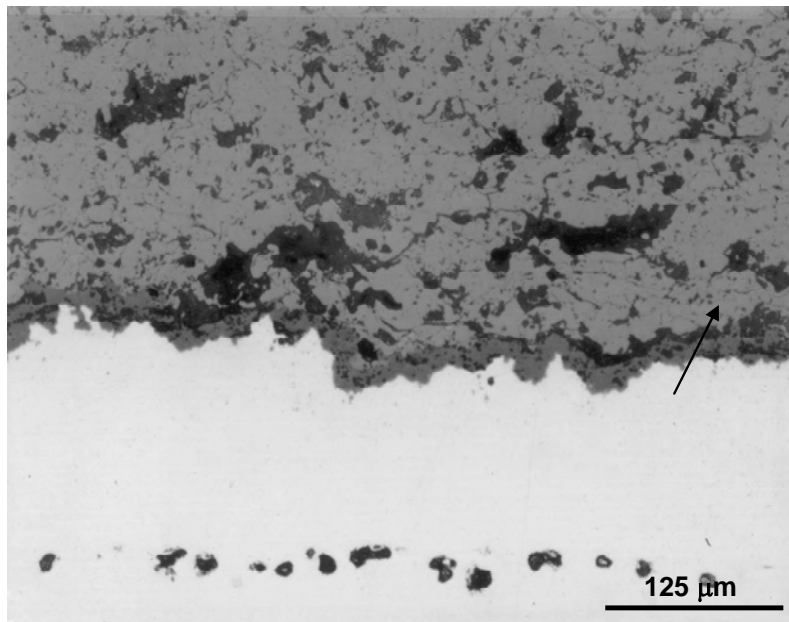
Figure 5-23
Optical micrographs of the TBC/NiCoCrAlY interface of GTD-111 specimens after (a) 2015 hours of exposure, (b) 5015 hours of exposure, (c) 9850 hours of exposure, and (d) 12030 hours of exposure at 1850°F (1010°C) showing variation of the interface cracking.

Though visual examination of the specimens showed no external cracks in the TBC, severe interface cracking was observed in all the specimens after long-term isothermal exposure (> 4000 hours at 1850°F (1010°C) or 1900°F (1038°C)). The interface cracks in some of the specimens extended for up to approximately 30% of the circumference of the transverse section of the specimen. The presence of these TGO/bond coat interface cracks in the specimens did not produce any visible external cracks in the TBC or cause localized TBC spallation. This suggests that an air-plasma sprayed TBC system is capable of enduring significant localized interfacial cracking prior to spallation. Cheruvu et al. reported similar results in Reference 12. These results also indicate that either the interface cracks present in the as-coated condition or the cracks initiated in the early stages of exposure propagate with exposure time prior to either external cracking and/or spallation of the TBC. The TGO-induced interface cracking is implicitly assumed to be directly related to TBC spallation or external surface cracking of the TBC.

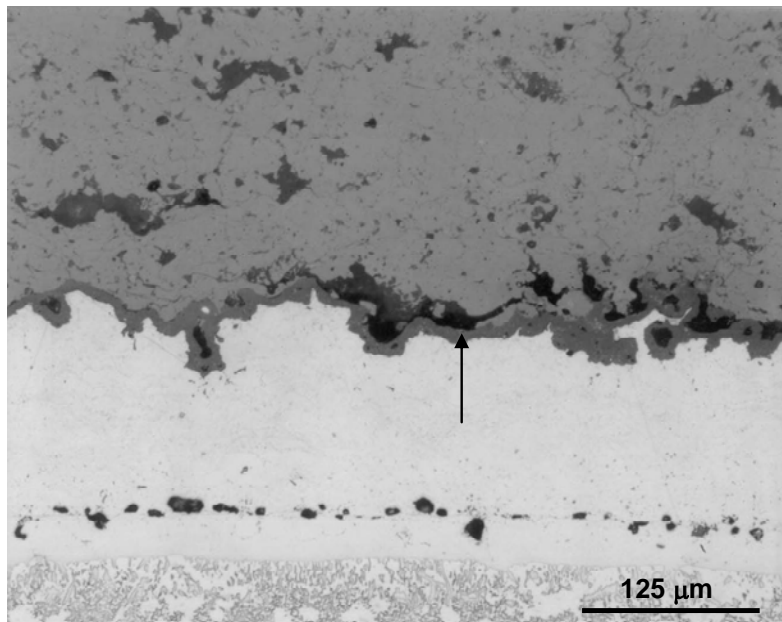
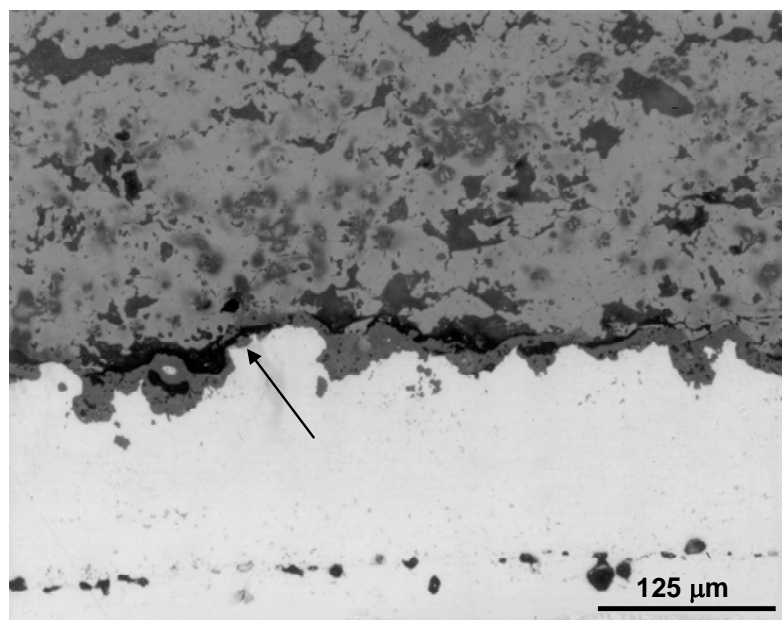
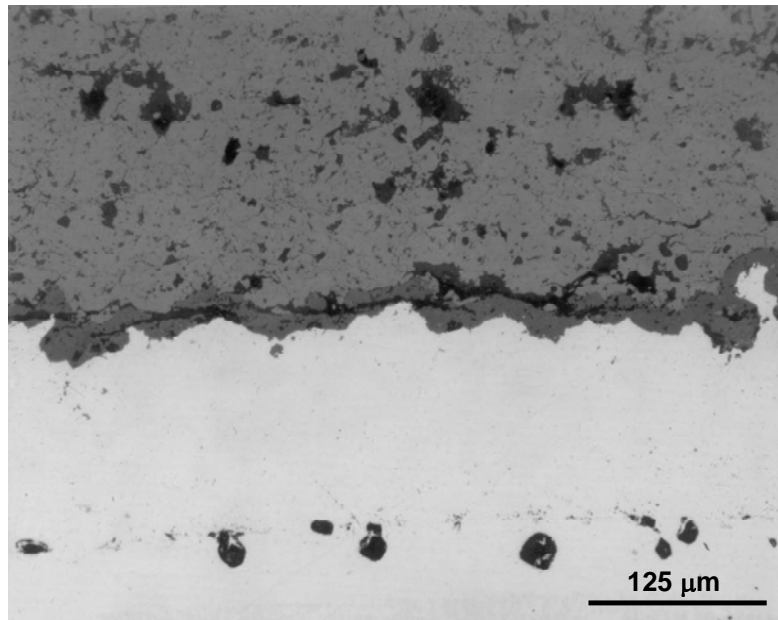
Figure 5-24
Optical micrographs of the TBC/NiCoCrAlY interface of IN-738 specimens after (a) 2015 hours of exposure, (b) 5015 hours of exposure, (c) 9850 hours of exposure, and (d) 12030 hours of exposure at 1850°F (1010°C) showing variation of the interface cracking.

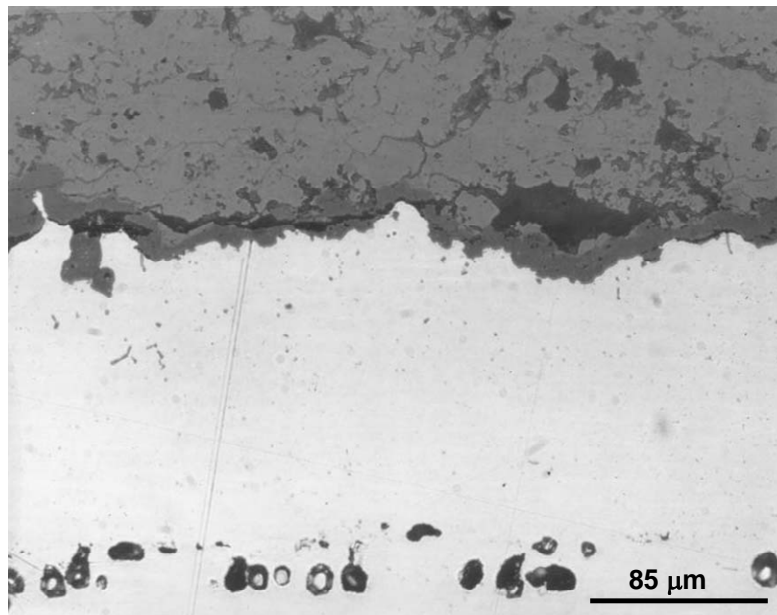
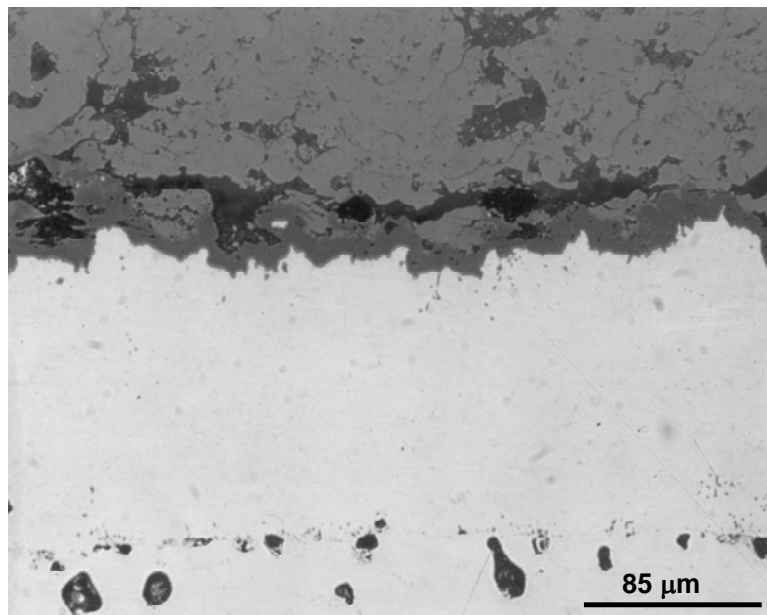
Figure 5-26
Optical micrographs of the TBC/NiCoCrAlY+Pt interface of IN-738 specimens after (a) 1005 hours of exposure and (b) 2015 hours of exposure at 1950°F (1066°C) showing variation of the interface cracking.

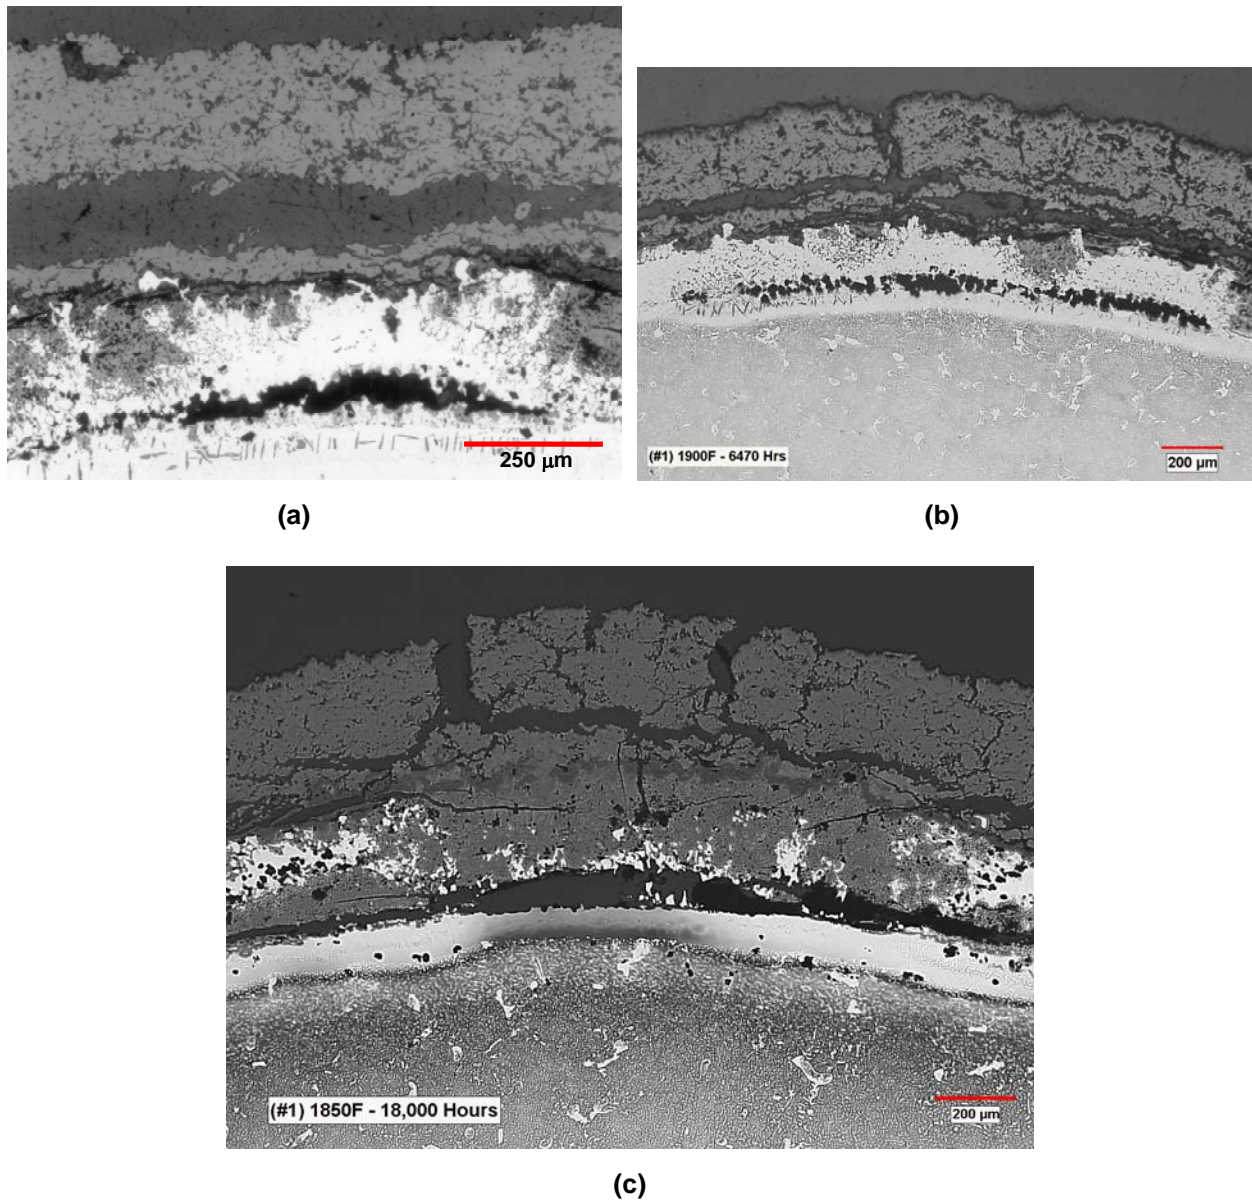
Figure 5-32
Optical microstructure of the NiCoCrAlY bond coating on GTD-111 after (a) 2925 hours of exposure at 1950°F (1066°C), (b) 6470 hours of exposure at 1900°F (1038°C), and (c) 18,000 hours of exposure at 1850°F (1010°C). Note the onset of bond delamination and void coalescence at the bond coat/substrate interface.

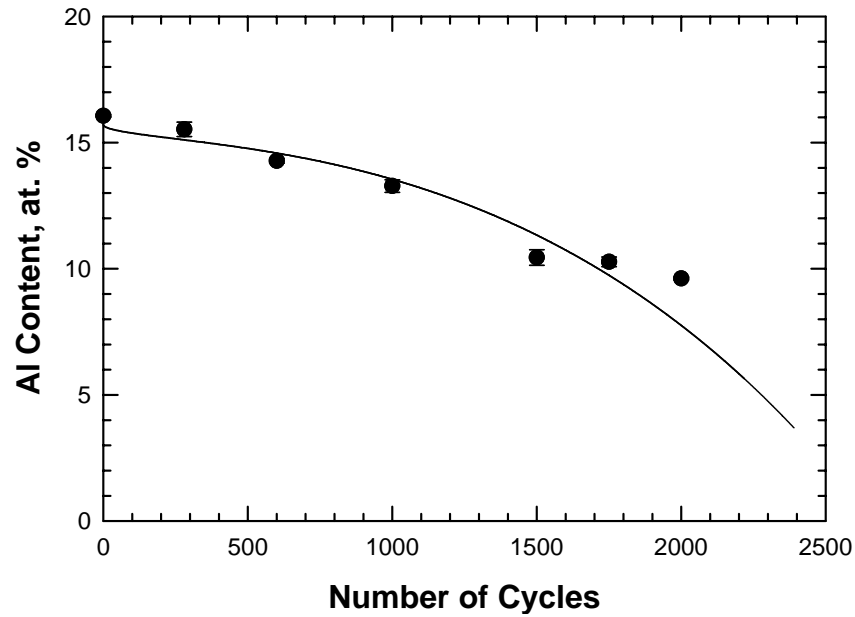
Figure 5-38 shows a comparison of the model fitting and measured Al content of GT33-like coating as a function of thermal cycles for a peak cycling temperature of 1950°F (1066°C). The computed β -depletion and weight change curves are compared against experimental data in Figures 5-39 and 5-40, respectively. Figure 5-40 indicates that the coated specimens showed more spallation than that predicted by the model. The discrepancy was partly due to experimental scatter and partly due to the formation of alumina, yttria, and chromia after 1000 thermal cycles. EDS analyses of the oxide scales indicated that a scale of mostly alumina oxides with dispersed Y-rich oxides (see Figures 5-41(a) and (b)) formed on GT33 in specimens after 600 thermal cycles. Figure 5-41(a) shows an SEM micrograph of the oxide scale, while Figure 5-41(b) presents EDS results that indicate that the oxide scale is comprised mostly of aluminum with some yttrium. In contrast, the oxide scale formed after 1500 thermal cycles consisted of a mixture of alumina, yttria, and chromia. Figure 5-42 shows the mixed oxides, and Figures 5-43(a), (b), and (c) show the compositions of the Al-rich, Cr-rich, and Y-rich oxides, respectively. The weight change curve computed by COATLIFE in Figure 5-40 was based on the formation and spallation of alumina. As a result, the model predicted less weight change than that observed in the experimental data since chromium and yttrium have higher atomic weights than aluminum. Since COATLIFE uses the Al content and volume fraction of the β for predicting coating life, the contribution of weight change due to the contribution of weight change due to Al depletion is modeled accurately, while that due to other elements (such as Cr, Ni, and Y, etc.) is ignored. This has proved very successful for accurately predicting the life of other duplex and diffusion coatings [1-4].

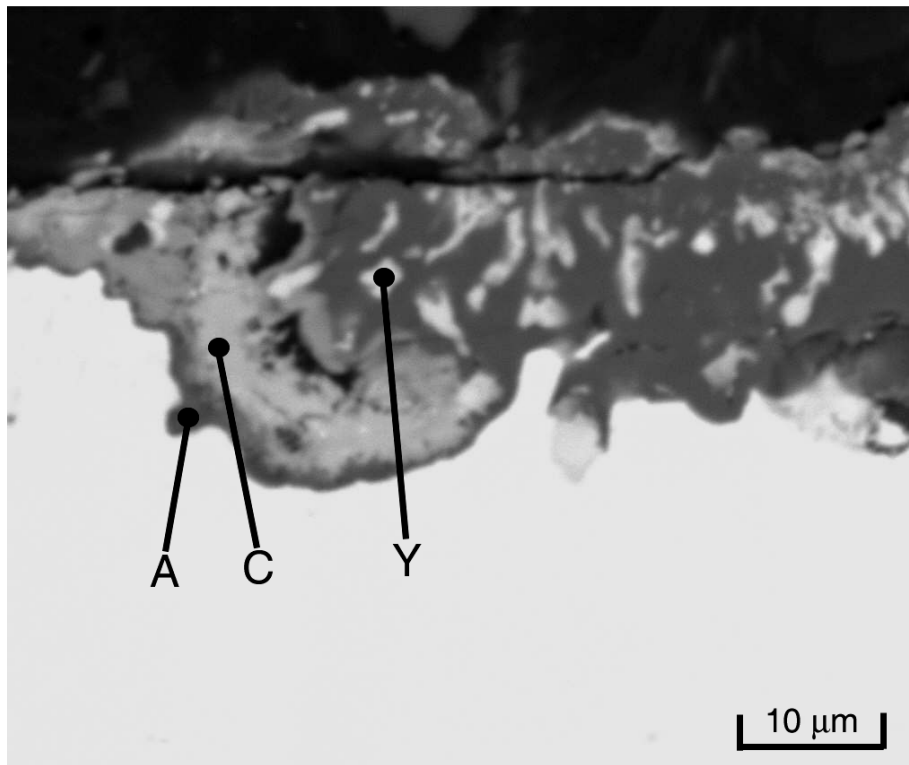
Figure 5-42
SEM micrograph shows that three oxides (A, C, and Y) are present in the scale formed on the GT33-like coating after 1500 one-hour thermal cycles between 77°F (25°C) and 1950°F (1066°C).

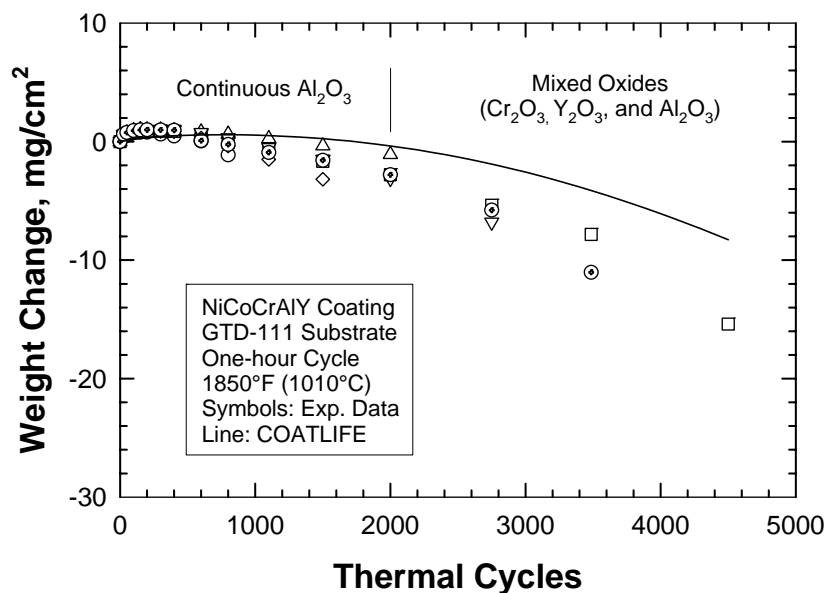
Figure 5-44

Comparison of computed and measured weight changes data of NiCoCrAlY (GT33-like coating) at 1850°F (1010°C). Deviations of computed and measured weight changes for thermal cycles greater than 2000 cycles were caused by the formation of alumina, yttria, and chromia in the experimental data, rather than a continuous layer of alumina as assumed in the model.

observed weight change curves. The observed weight changes are larger than those predicted by the model after 1000–2000 thermal cycles. The corresponding Al contents and volume fraction of β phase are shown in Figures 5-45 and 5-46, respectively. In both cases, the computed values of the Al content and the volume fraction of β phase are lower than the experimental data when the thermal cycle exceeds 2000. This finding indicates that Al and β -phase depletion occurs at lower rates than model prediction. Chemical analyses of oxides formed on the surface specimens indicated that the oxide layer contained a mixture of alumina, yttria, and chromia when the number of thermal cycle exceeded 2000 cycles. In addition, oxidation pits, which are indicative of localized oxidation, were observed in specimens after 3500 thermal cycles. The discrepancy between model prediction and experimental data was therefore due to the absence of a continuous alumina scale on the oxidized surfaces.

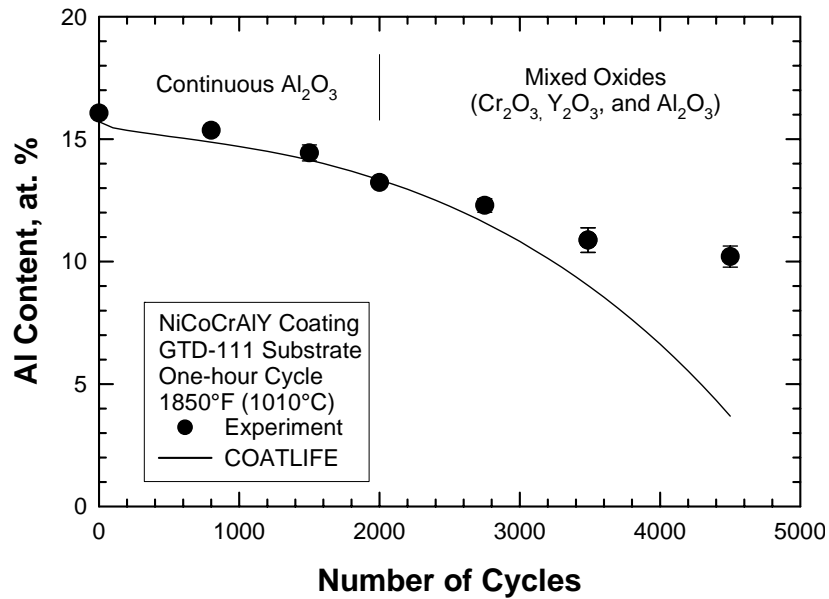
Figure 5-45
Al depletion compared against experimental data for NiCoCrAlY (GT33-like coating) at 1850°F (1010°C).

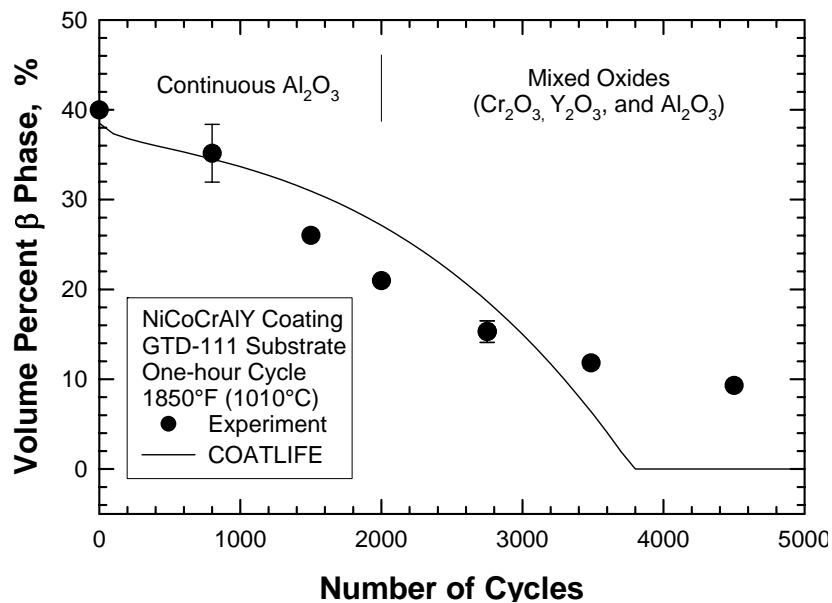
Figure 5-46
Computed volume percent of β phase compared against experimental data for NiCoCrAlY (GT33-like coating) at 1850°F (1010°C).
